**CALSPAN ON-SITE AIR BAG/CHILD FATALITY INVESTIGATION**

**CALSPAN CASE NO. 96-15**

**VEHICLE - 1995 MAZDA PROTÉGÉ'**

**LOCATION - OHIO**

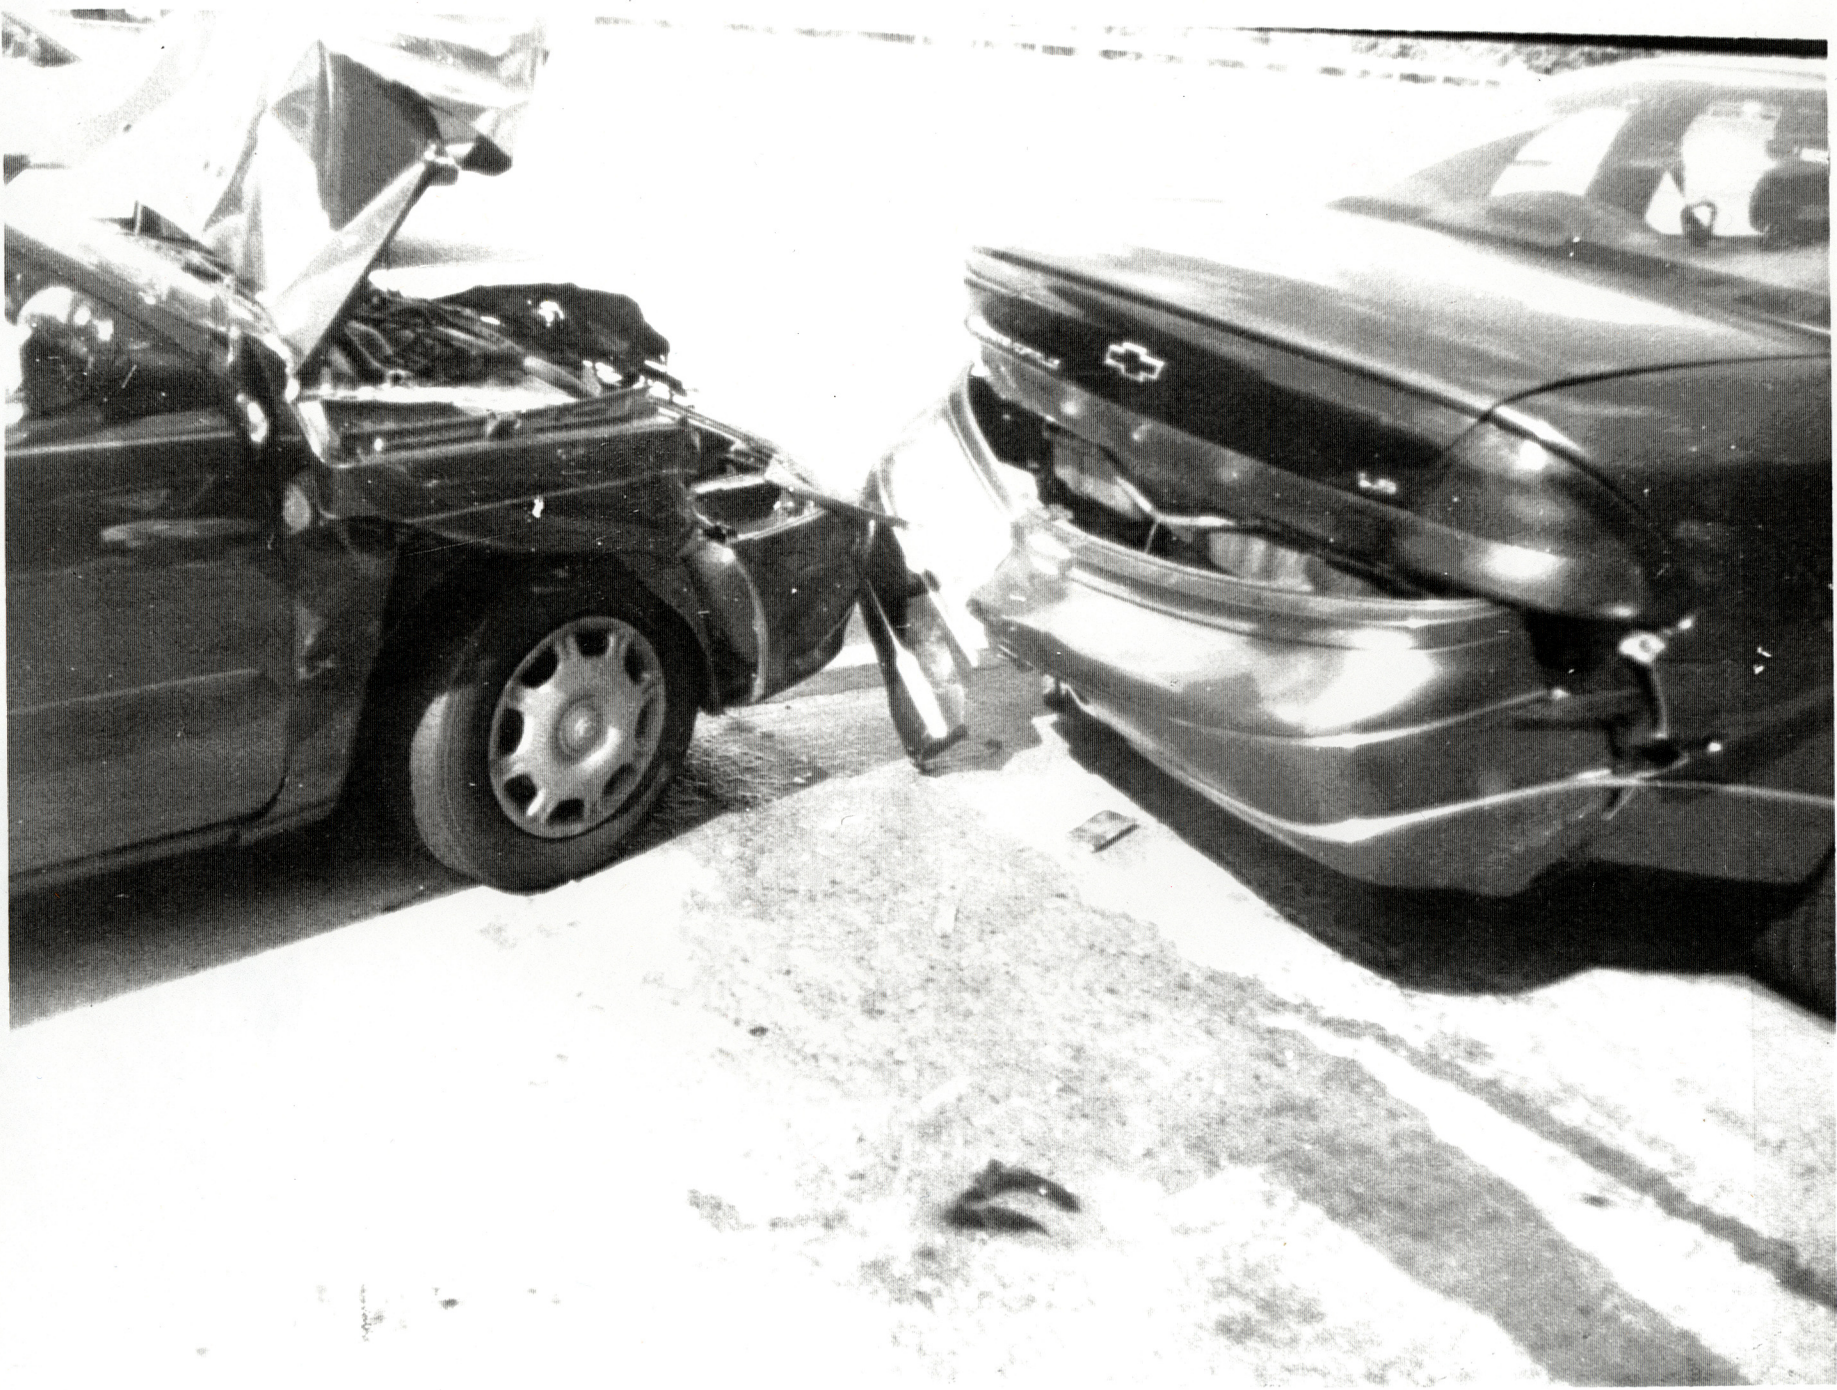
4. Impact damage of the 1995 Mazda Protégé and the 1995 Chevrolet Monte Carlo.

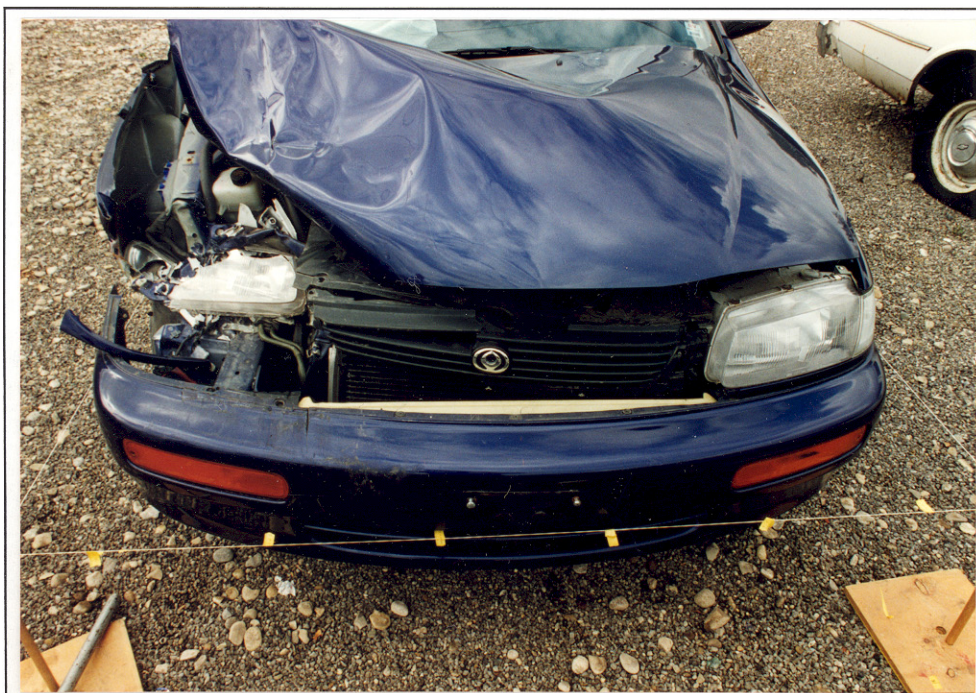
The right frontal area of the Mazda struck the left rear bumper of the Monte Carlo. Due to the pre-impact braking of both vehicles, the front bumper of the Mazda underrode the rear bumper of the Monte Carlo. The Mazda sustained direct contact damage which began 16.3 cm (6.4 in) right of center and extended 56.1 cm (22.1 in) to the right corner. The front bumper was crushed 1.4 cm (0.5 in) at the right corner. However, the right corner of the upper radiator support panel and the leading edge of the right front fender was crushed to a maximum value of 19.3 cm (7.6 in). Crush values measured at the upper radiator support were as follows: C<sub>1</sub>= 2.3 cm (0.9 in), C<sub>2</sub>= 5.4 cm (2.1 in), C<sub>3</sub>= 6.0 cm (2.4 in), C<sub>4</sub>= 10.8 cm (4.3 in), C<sub>5</sub>= 19.3 cm (7.6 in), C<sub>6</sub>= 15.6 cm (6.1 in).

2. View of the frontal damage of Vehicle 1.

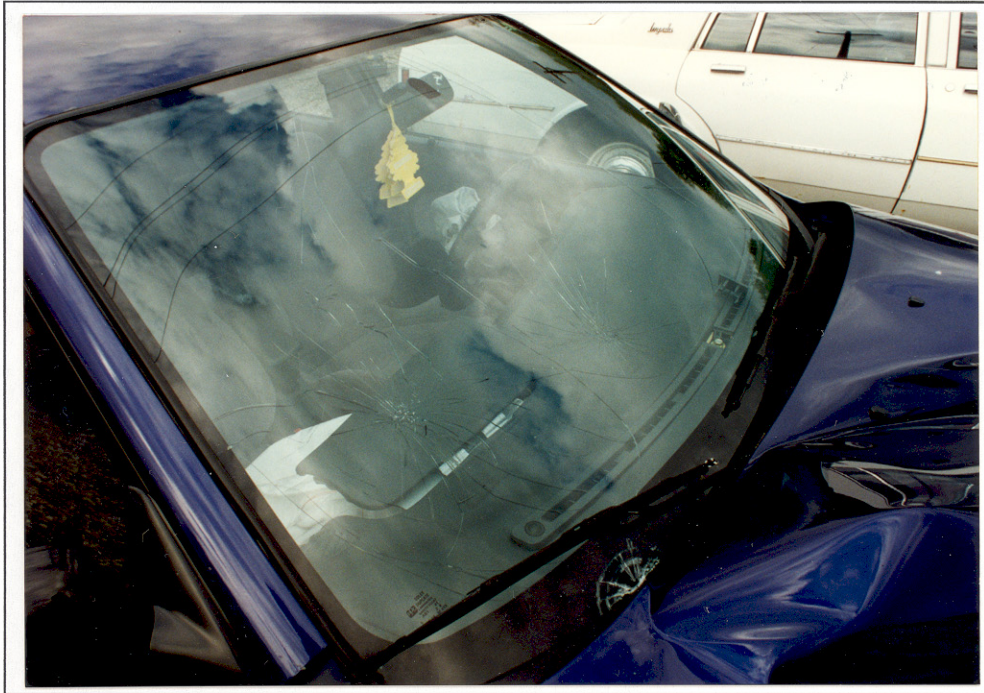
The windshield glazing was cracked in two areas. One of the spider web-type fractures was located 14.0 cm (5.5 in) above the instrument panel and 20.3 cm (8.0 in) right of center and the other was located 15.9 cm (6.25 in) above the instrument panel and 47.0 cm (18.5 in) right of center. The upper boundary of the fractures was 6.4 cm (2.5 in) below the header and extended downward to 26.7 cm (10.5 in) above the instrument panel. A vertically oriented vinyl transfer extended across the windshield between the two fractures (refer to Photograph No. 56). The transfer started 14.6 cm (5.75 in) right of center and 8.9 cm (3.5 in) above the top of the instrument panel and extended horizontally 33.5 cm (13.2 in) to the right to a point 6.4 cm (2.5 in) above the top of the instrument panel. Air bag fabric transfers on the windshield started 2.5 cm (1.0 in) left of the center and extended to the right 7.0 cm (2.75 in) inboard of the right A-pillar. The rear view mirror was canted to the left by the deploying passenger side air bag but was not damaged. An air bag transfer 5.1 cm (2.0 in) wide and 6.4 cm (2.5 in) high was noted on the right side of the back of the rear view mirror, (reference Photograph No. 60). The right sunvisor was deformed at the outboard hinge point as a result of contact by the handle of the child restraint as it was pushed upward by the air bag module flap and deploying air bag, (refer to Photograph No. 58). The passenger side air bag exhibited evidence of contact (transfers) with the back of the rear-facing child restraint. The glove box door was open at the time of the investigation.

17. View of the right side windshield fractures.

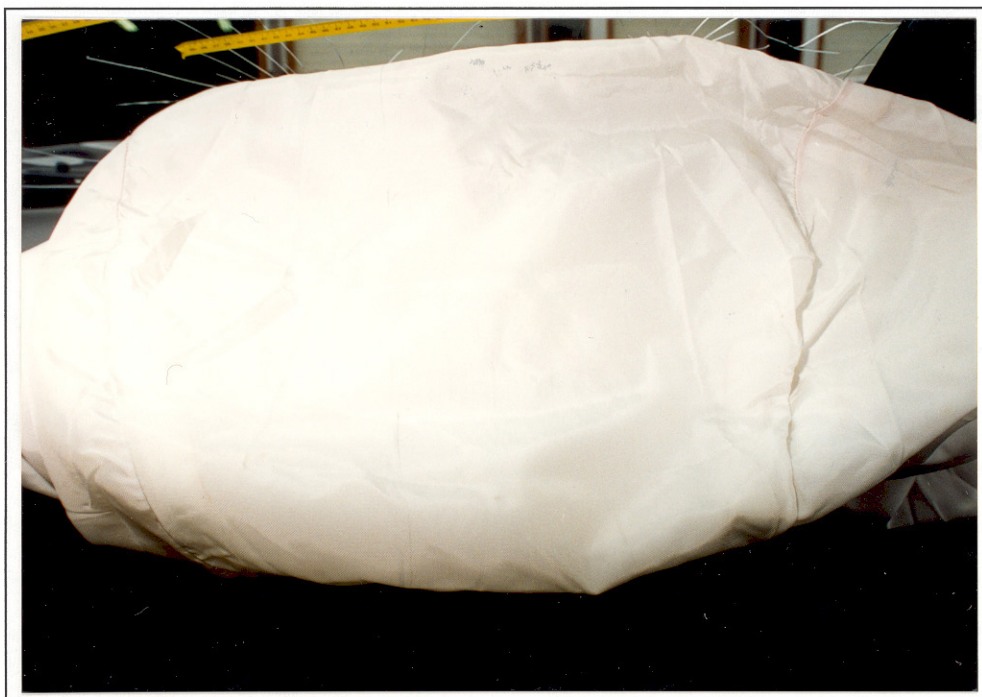
40. View of transfers on the face of the deployed passenger air bag.

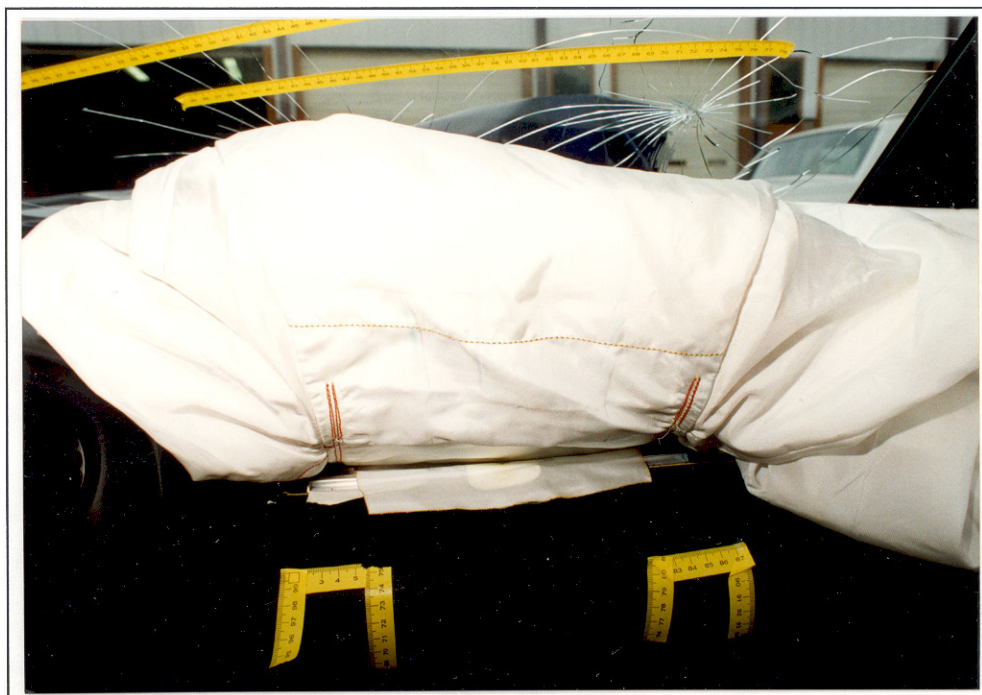
A 30.5 cm (12.0 in) vertical large black vinyl transfer was noted on the right side of the passenger side air bag below the right vent port which began 10.2 cm (4.0 in) out from the inflator. The bottom of the air bag revealed 15.2 cm (6.0 in) vertically oriented blue/green cloth transfers from the child restraint cloth cover. The cloth transfers were located 14.6 cm (5.75 in) rearward of the inflator extending over an area from the right seam horizontally left 19.1 cm (7.5 in). In that same area was a 11.4 cm (4.5 in) wide pattern of gray/black vinyl rubber transfers. The transfers extended 53.3 cm (21.0 in) up onto the bottom face of the bag.

41. View of the blue/green transfers on the lower surface of the deployed passenger air bag.

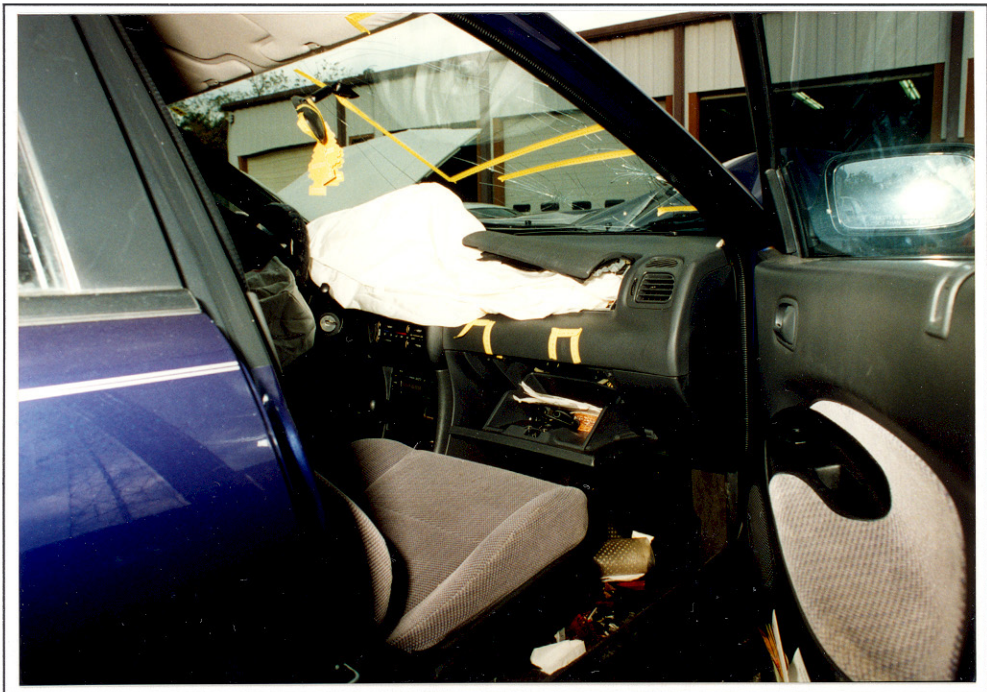
42. Angular view of the right front interior and interior contacts, (highlighted).

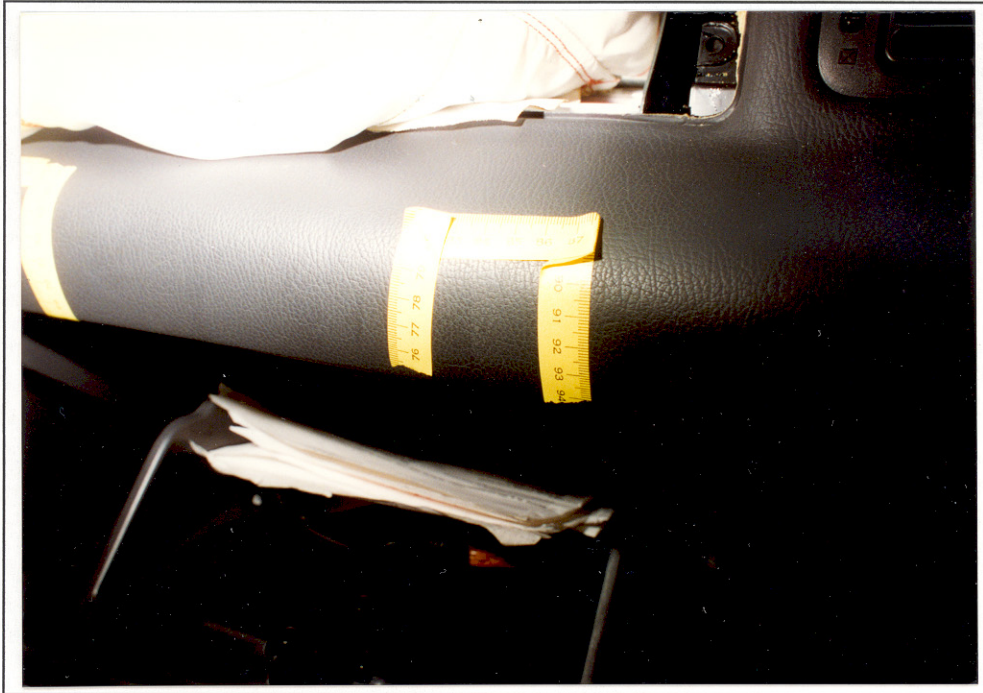
The child restraint contacted the mid instrument panel below the passenger side air bag module during pre-impact braking, scuffing the leading edge of the instrument panel in two locations. Two 5.1 cm (2.0 in) vertical contact marks from the back struts of the child restraint shell were located 21.0-22.2 cm (8.25-8.75 in) and 43.8-45.1 cm (17.25-17.75 in) right of center (refer to Photograph Nos. 62 through 67). With the child restraint in this forward position, the module cover flap contacted the back of restraint, fracturing the restraint shell during initial deployment. The module cover flap then continued its upward rotation, contacting and fracturing the windshield (refer to Photograph No. 49).

48. Close-up view of a scuff mark on the leading edge of the IP caused by the child restraint.

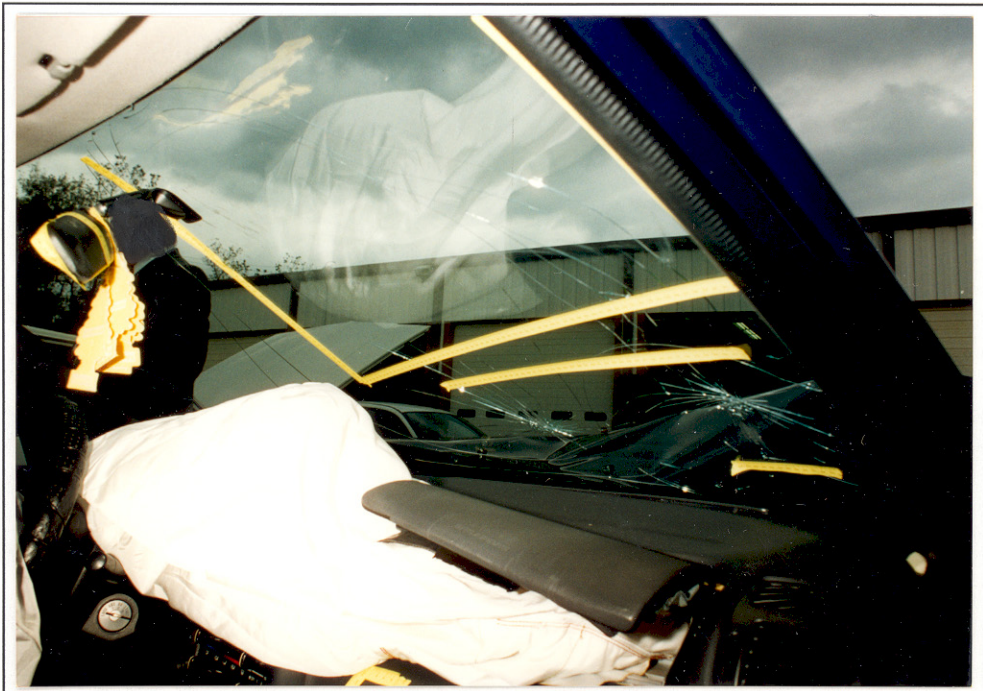
49. Overall view of the windshield fractures caused by the extended module cover.

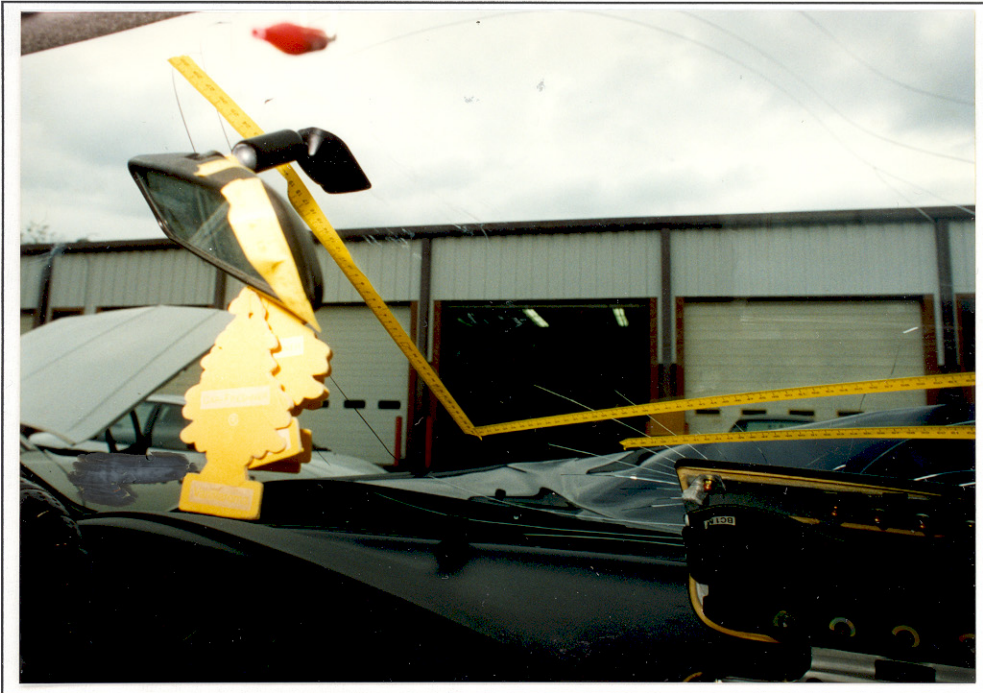
52. View of the fractures in the center of the windshield.

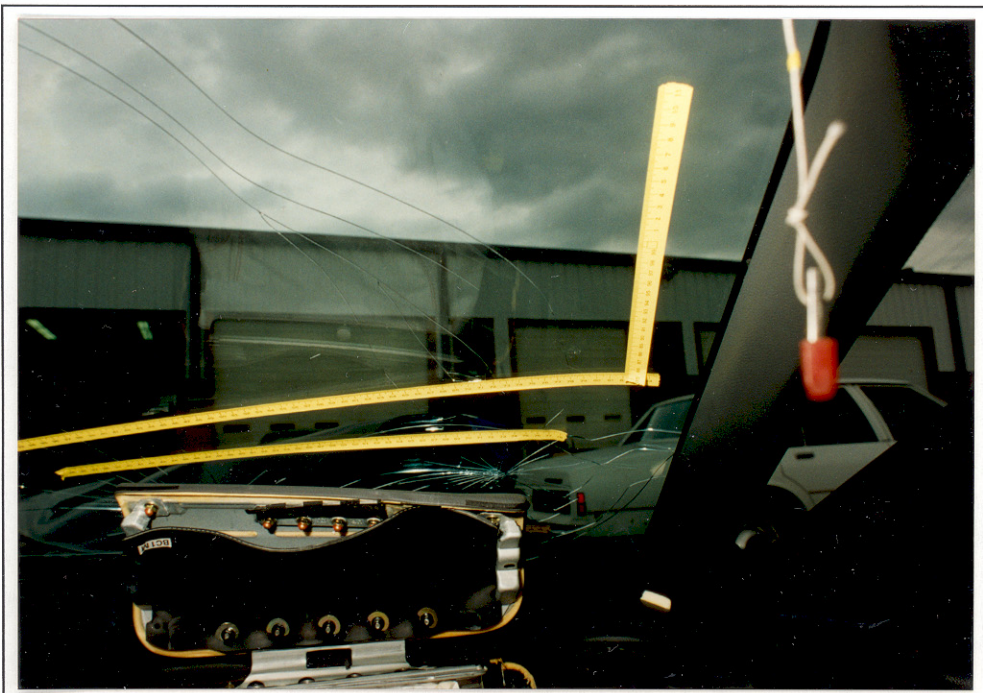
53. View of the right windshield fractures.

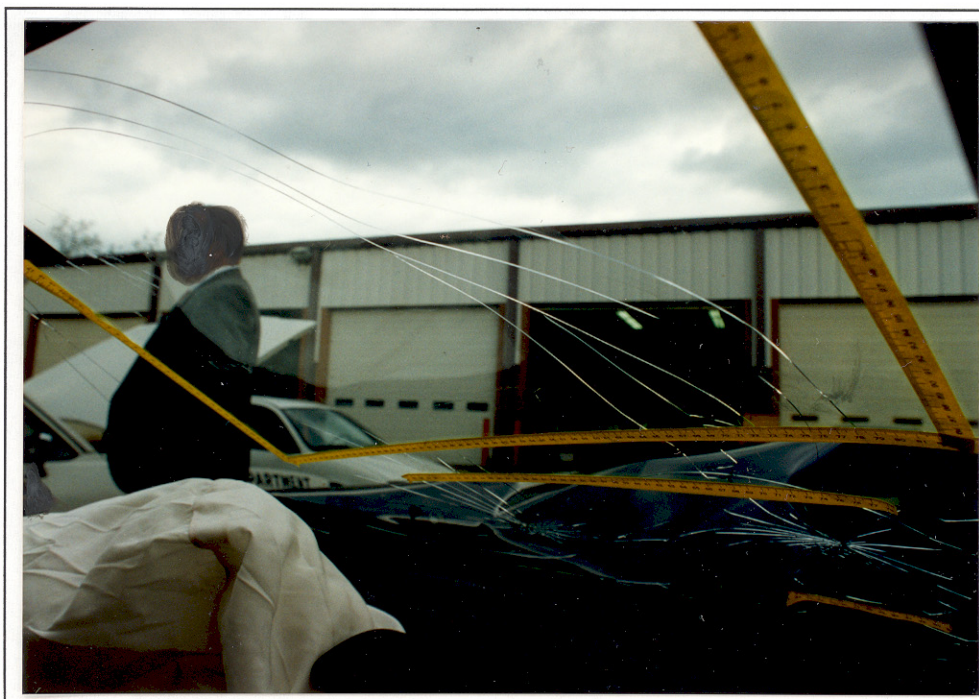
54. Overall view of the windshield fractures.

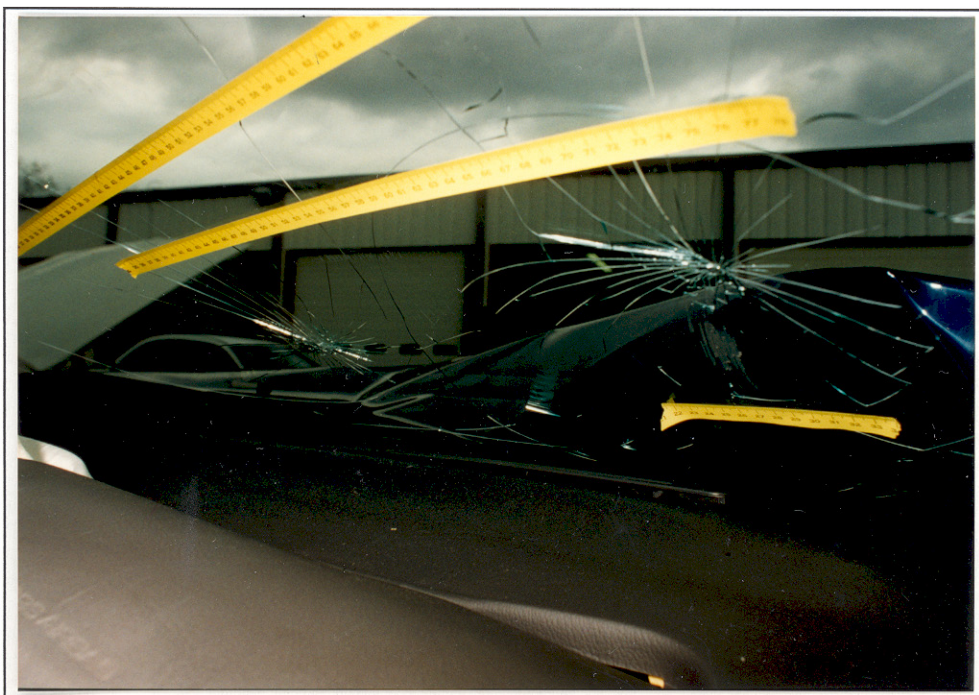
55. Close-up view of the fractures caused by the module cover.

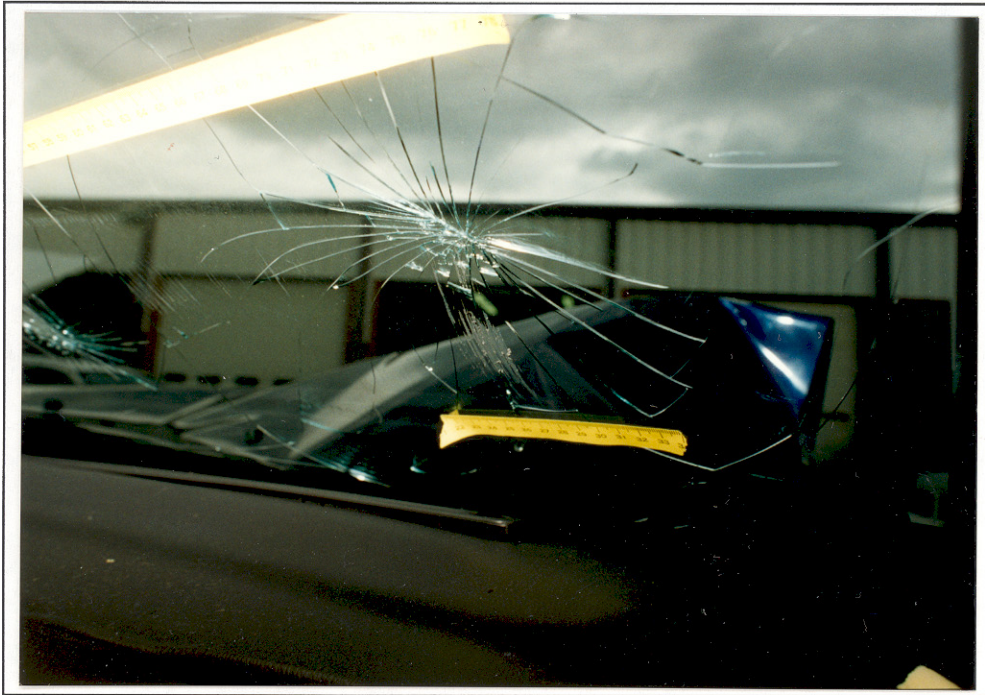
56. Close-up view of the right fracture in photo 55.

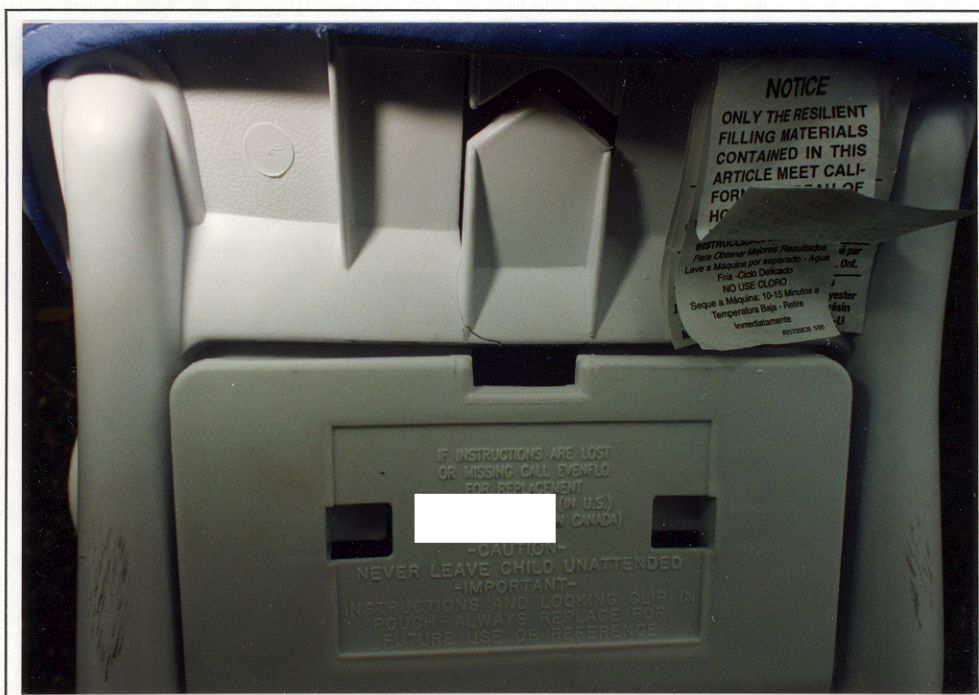
The module cover flap and deploying non-tethered air bag fabric subsequently contacted the back of the child restraint and fractured the plastic shell. Three fractures were documented: the first was located on the upper segment at the top of the compartment door, the second was located at the base of the right outboard vertical reinforcement, and the third was located at the compartment door hinge point. The deployment of the air bag probably displaced the child restraint rearward into the right front seat back. There was no contact evidence to support this sequence. As a result of the air bag deployment, the infant sustained multiple skull fractures (AIS-2) and brain swelling (AIS-3).

A storage compartment was manufactured into the upper aspect of the plastic shell of the infant restraint. The door for this compartment was hinged at the bottom and was equipped with a top center plastic tab which served as a latch to access the compartment. Both hinge points for the storage compartment were cracked (refer to Photograph No. 77) and a 2.5 cm (1.0 in) crack was located left of the plastic latch (as viewed from the rear). The following data was embossed into the door panel (refer to Photograph No. 79):

79. Overall view of the fracture and contacts to the back of the child restraint.

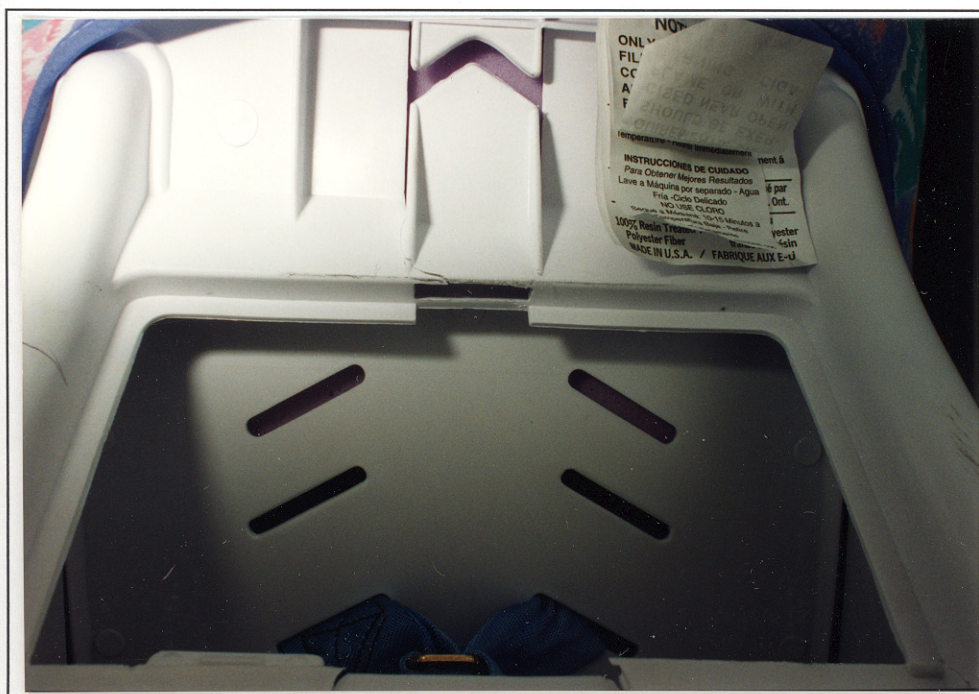
80. View of the fracture of the center back of the child restraint.

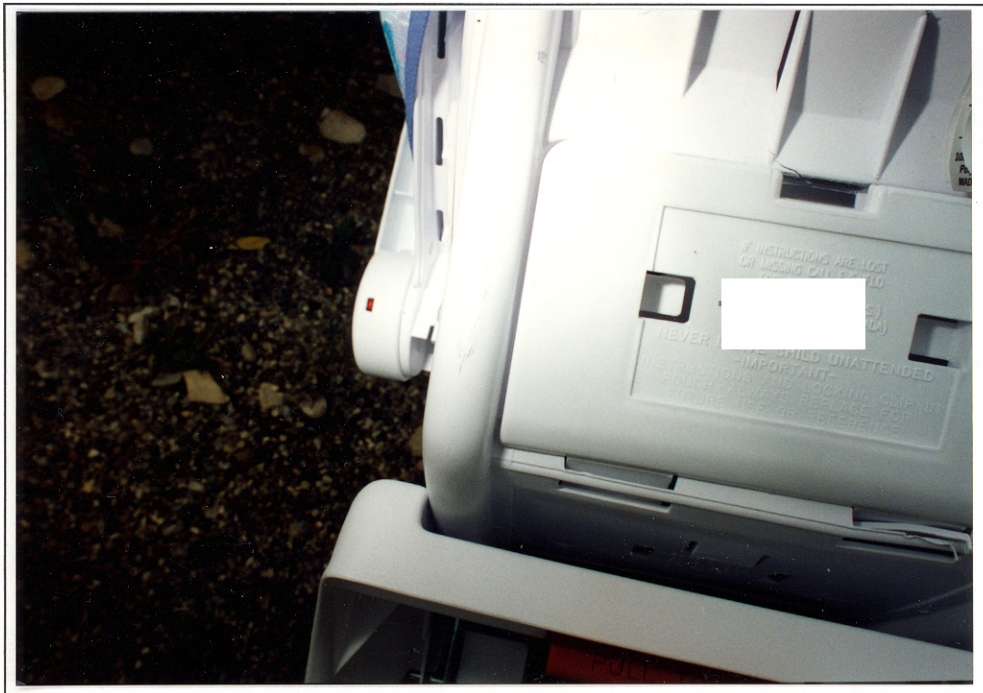
Both rear vertical reinforcements of the restraint had gray vinyl transfers as a result of contact with the right instrument panel during the vehicle's pre-impact braking (refer to Photograph No. 81 and 82). Viewing the child restraint from the rear, the transfer on the left vertical reinforcement was 4.1 x 1.3 cm (1.6 x 0.5 in) and the transfer on the right vertical reinforcement was 3.8 x 1.0 cm (1.5 x 0.4 in). A 3.8 cm (1.5 in) crack in the plastic shell was located at the lower left of the right vertical reinforcement (refer to Photograph No. 83).

81. Close-up view of a vinyl transfer to the left side reinforcement of the child restraint.

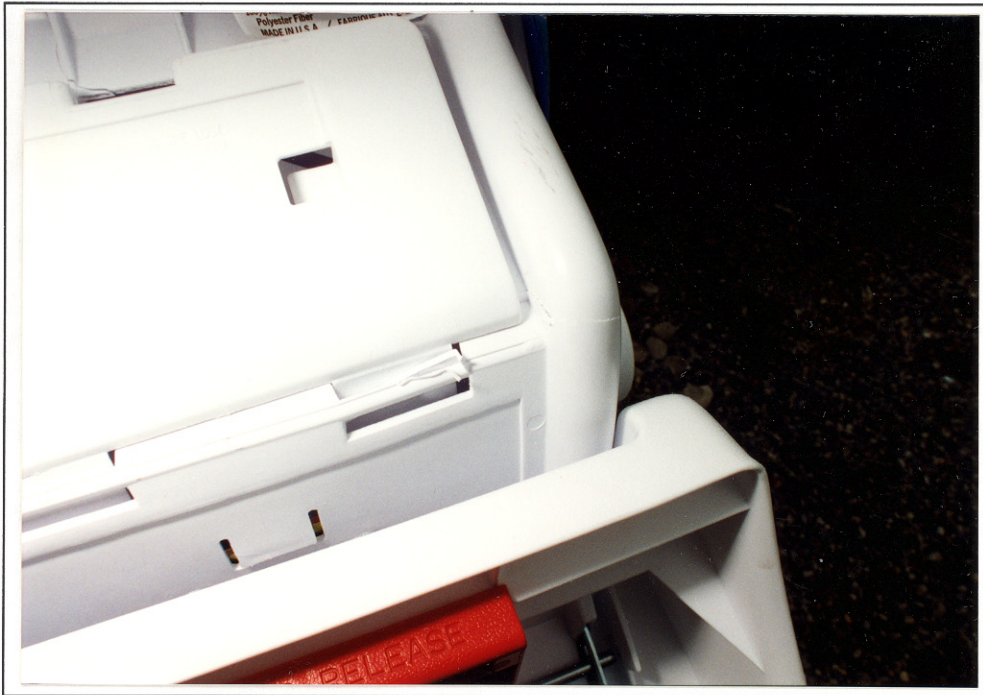
83. View of the fractured hinge of the rear compartment door.

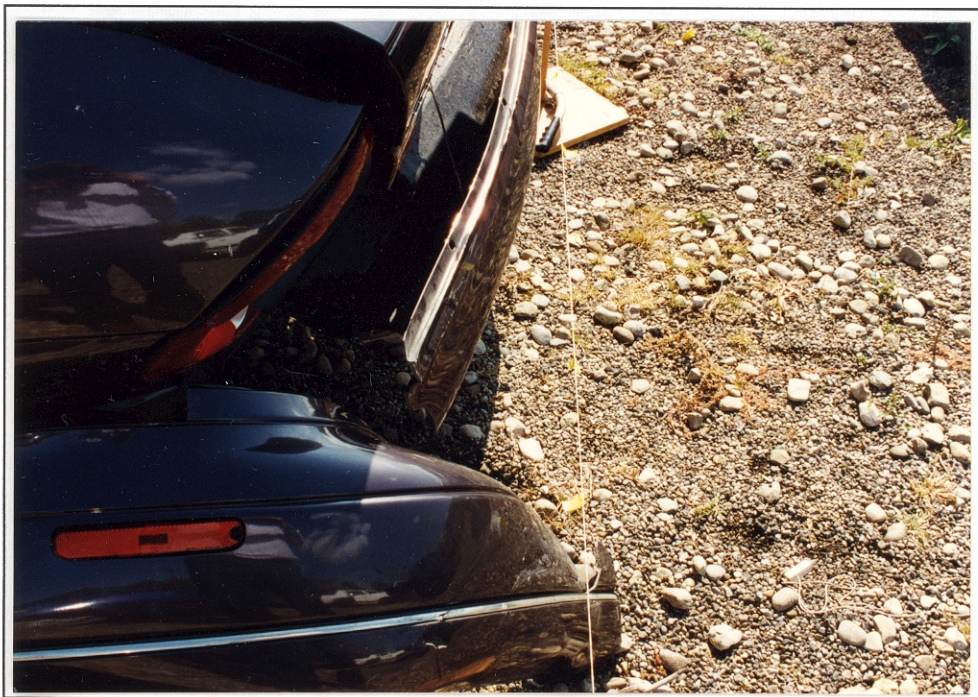
The Monte Carlo sustained moderate damage that resulted from the rear-end impact sequence with the Mazda Protégé'. The rear bumper fascia of the Monte Carlo was separated from the reinforcement bar and fractured. The left corner of the rear bumper reinforcement bar was crushed to a depth of 32.9 cm (13.0 in). The direct contact damage began on the rear bumper fascia 10.2 cm (4.0 in) left of center and extended 59.7 cm (23.5 in) toward the left rear corner.

97. Close-up view of the left rear damage.

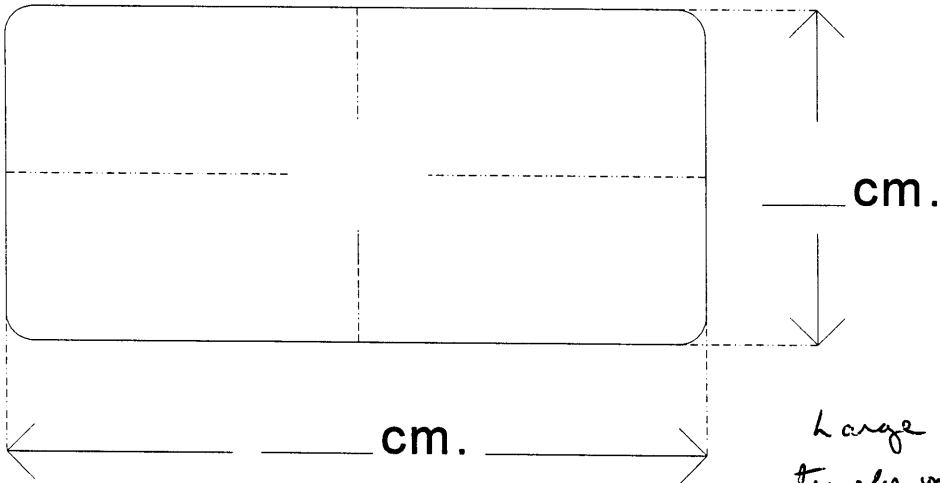
Large black vinyl  
transfer on (R) side of  
PAB, 30.5" horizontally,  
begin 10.2cm outboard  
of inflator
